USS IWO JIMA Mishap

A Set-up for Failure

Bryan O'Connor
Chief,
Office of Safety and Mission Assurance
NASA Headquarters, Washington, DC
OSMA POC, Brian Hughitt (202) 358-1572

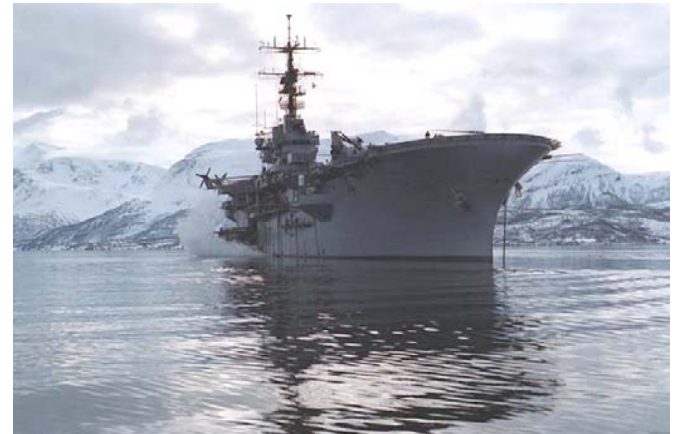
Contributing Factors

- Repair specifications did not identify fastener part numbers
- Ships Force did not provide contractor Standard Parts List
- Inadequate supervision for installation of Level I material
- No evidence that Government hold point inspections were performed
- Inadequate knowledge of Level I material requirements
 - Segregation from non-Level I
 - Segregation of look-alike parts
 - Markings
 - Color coding
 - Documentation

- Identified all BOCBF substitution hazards on Navy ships
- Mass inspection of in-service fasteners (scrape or magnet)
- Purged stocks & replaced with shiny brass or monel fasteners
- Revise parts lists to flag Level I fasteners and include warning notes
- Training curricula modified to include Level I awareness (engineers and mechanics)
- Fastener Selection training video disseminated Navy-wide
